# Manhole Inspection Summary

Manhole # S35Q\_\_075MH

Insp Date: **3/20/08 10:22 AM**

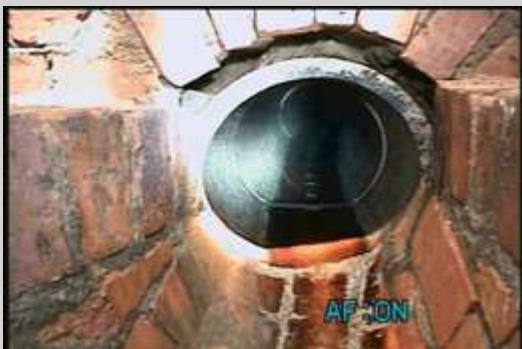
3 O'Clock Inflow

8 in. Circular Gravity Sewer  
Pipe In @ 3 O'Clock

Pipe Height: 0 (in.) Direct

Pipe Material: **Clay** ☐ Pipe Lined

Invert Depth: 8.88 (ft.) Flow Characteristics: **Fast**

Deposits: ☒ **None** ☐ Mud ☐ Sludge ☐ Debris ☐ Grease

Infiltration: **None** Pipe Seal Cond: **Unknown**

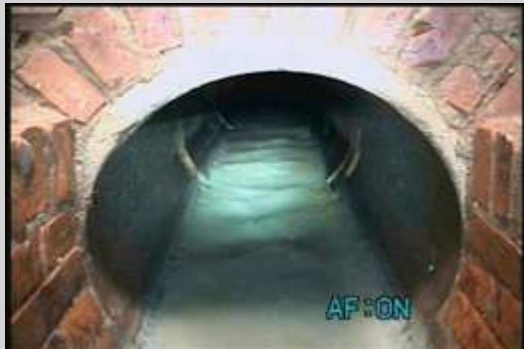
6 O'Clock Inflow

18 in. Circular Gravity Sewer

Pipe In @ 6 O'Clock

Pipe Material: **Clay** ☐ Pipe Lined

Invert Depth: **8.88** (ft.) Flow Characteristics: **Fast**

Deposits: ☒ None ☐ Mud ☐ Sludge ☐ Debris ☐ Grease

Infiltration: **None** Pipe Seal Cond: **Unknown**

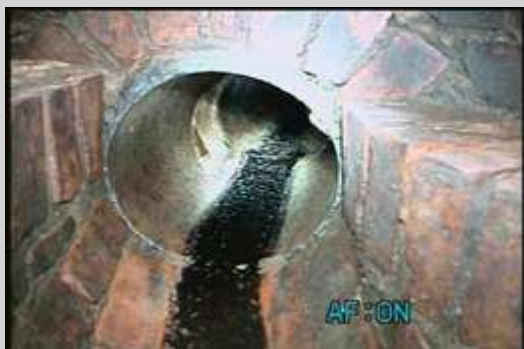
9 O'Clock Inflow

8 in. Circular Gravity Sewer

Pipe In @ 9 O'Clock

Pipe Material: **Clay** ☐ Pipe Lined

Infiltration: **None** Pipe Seal Cond: **Unknown**
